# OFFSHORE BOLT PROTECTION

On an offshore platform in the North Sea operated by Chevron and ConocoPhillips, Enviropeel was already successfully protecting small diameter flange bolts that had been severely affected by galvanic corrosion. So, when it came to choosing a system for bolt protection on a new linked platform, the operators decided that Enviropeel was the best approach to use as, even though the new platform was yet to be fully commissioned, it was already suffering from the corrosive effects of the saltwater environment on its bolted systems and needed immediate protection.

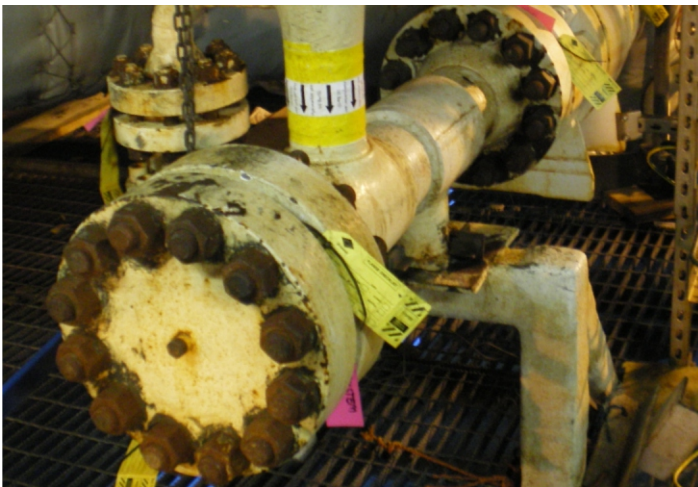
*Left: a typical flange with bolt corrosion after only a eighteen months.*

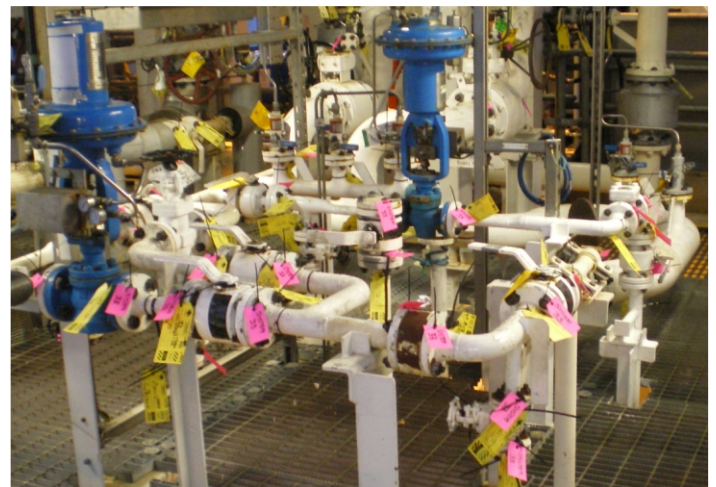
*Below: a small section from the platform showing the inspection tags indicating remedial action required.*
