PIPELINE REPAIR

Gas pipelines at the TNB Power Station in Johor, Malaysia required repair and refurbishment as the polyethylene tape wrap system was failing. Penetration of the wrapping system entrapped moisture causing rapid spread of corrosion throughout the 1.5 km of pipe. Stagnant, permanently wet conditions such as those created within failed wrapping systems creates pitting corrosion which can lead to significant reductions in metal thickness and threaten pipeline integrity.

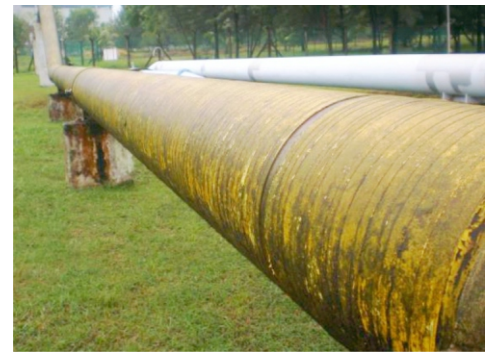
Above: the tape-wrap system has become a threat to the pipeline instead of protecting it. Rust products streaming from within the coating have stained the concrete supports

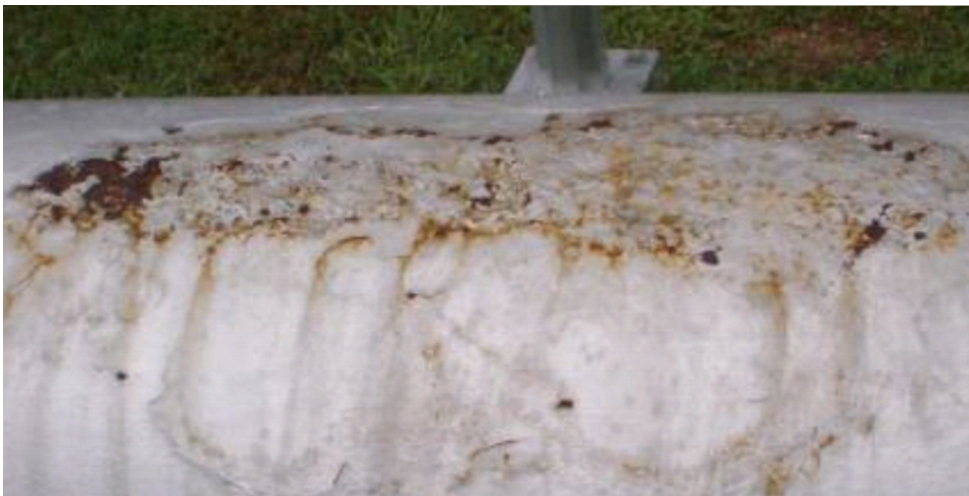
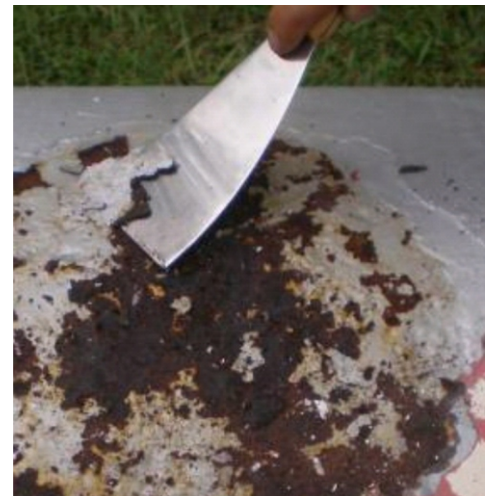
Left & below: removal of the wrapping reveals significant corrosion, blistering paint and pitting caused by the trapped water

First the failing wrap was removed, then surface preparation using a combination of blasting and power tools was undertaken. Two coats of Alocit 28.15 were carefully applied, with particular attention to coverage within pitted areas. Finally a cosmetic coat of a compatible PU was used.

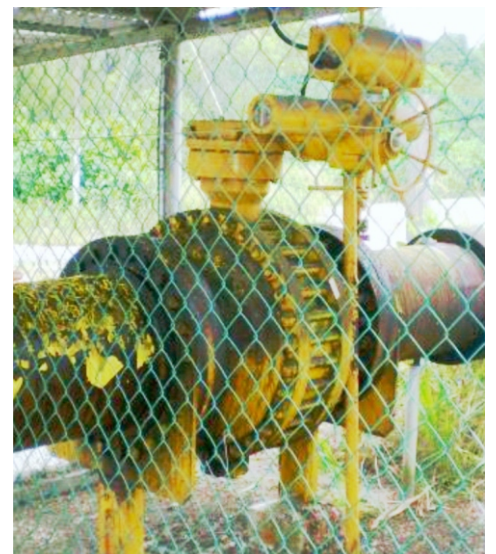
Below: valves, flanges and bolted systems were also under threat from corrosion

Once the painting was completed, all the bolted flange joints were protected with Enviropeel as, even when blasted and painted, bolted systems are prone to failure because of the complexity of their

structure. Enviropeel encapsulation provides a whole system, active protection that prevents the recurrence of corrosion in bolted systems. See our website for more details.

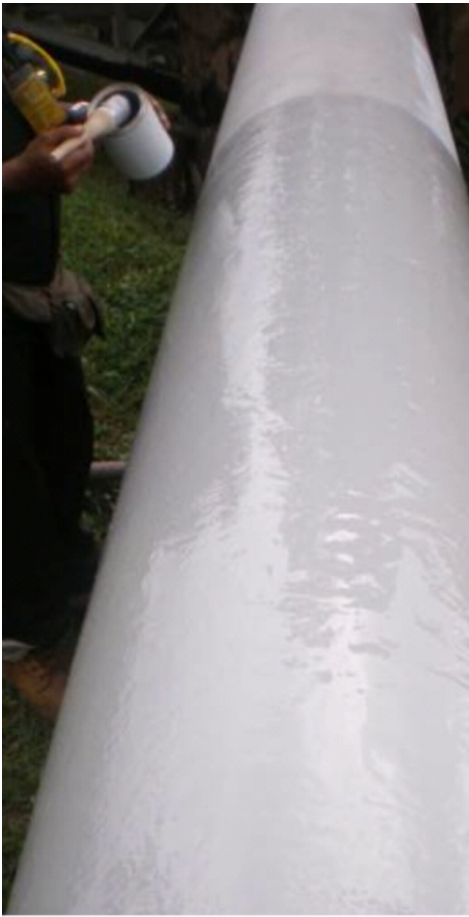
Above: Alocit 28.15 provides an extremely hard, long-lasting finish

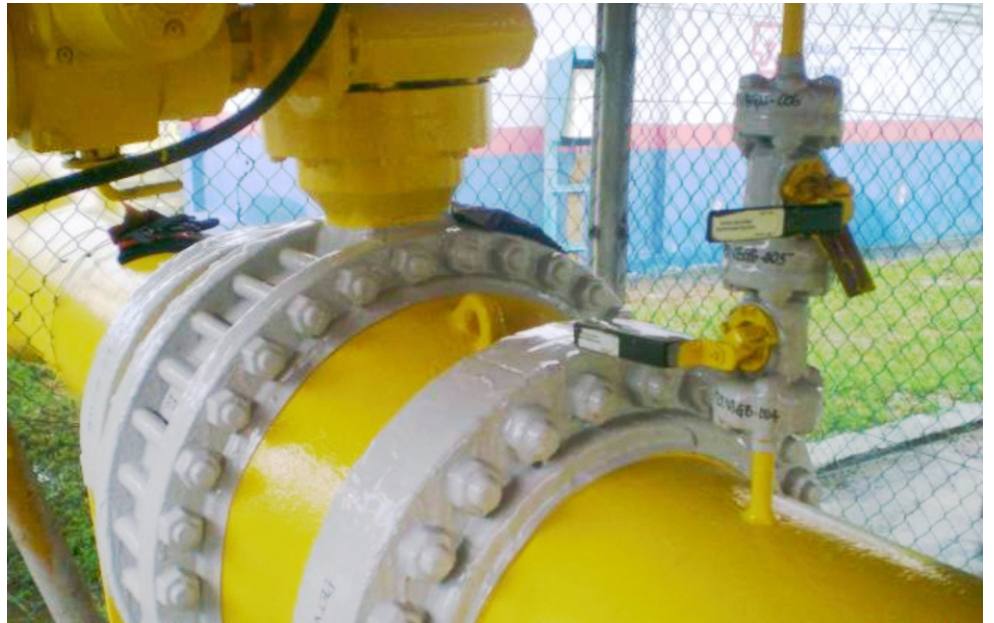
Above right and below: pipelines coated in Alocit with the addition of Enviropeel on bolted areas to provide the best possible protection.
