SUBMERGED PIPELINE TEST

Two test areas were completed: a 36" blind flange and a 12" blind flange in a soil-to-air interface.

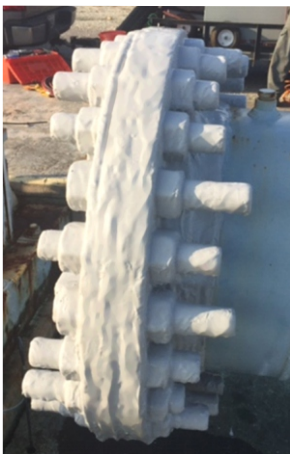
The photo on the right shows a 36" blind flange with visible corrosion present on the flange and fastenings. As part of the test, a section of the flange and the face of an adjacent nut were abraded to expose the underlying steel in order to investigate the effect of the application in areas

where no coating is present. Note the extent of the rust coming through the coating above the abraded patches. Application was completed on 10/12/16 (above left).

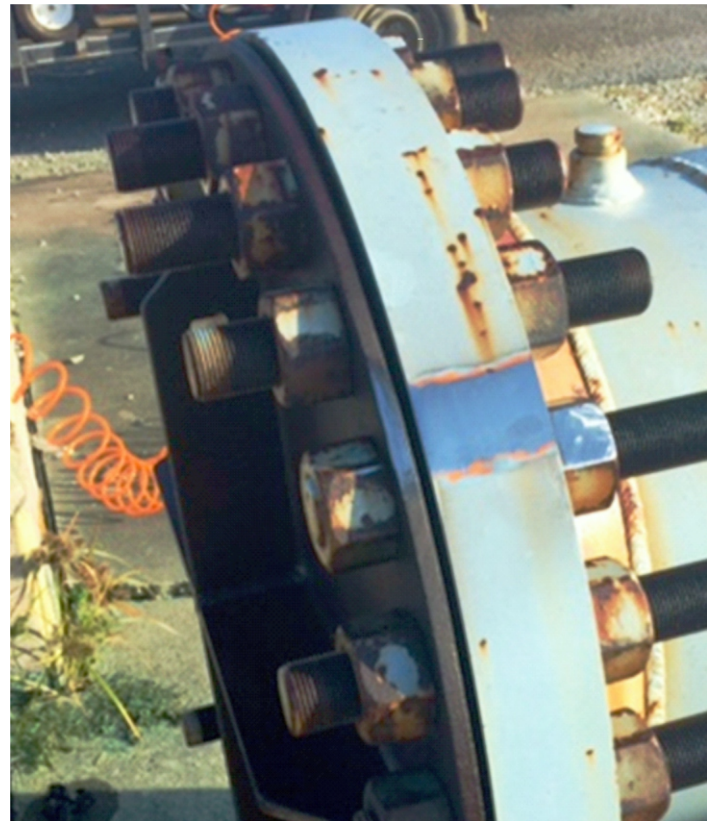
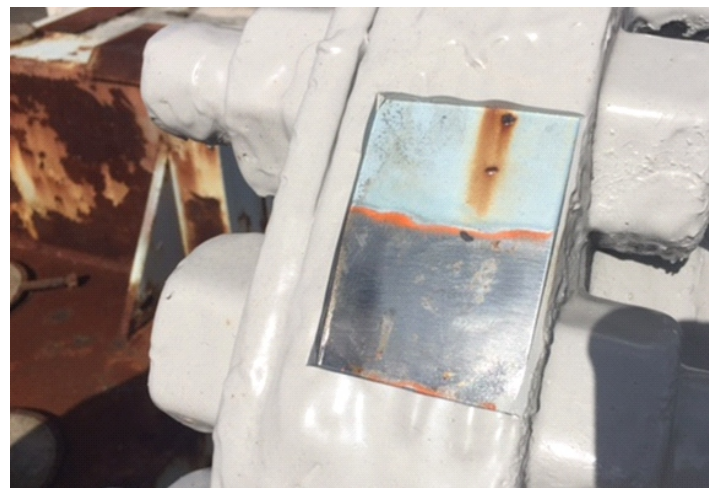
First inspection on 1/12/17 after 3 months.

A section of the coating around the abraded area was removed for the first inspection. As shown right, the exposed steel remained completely corrosion free and the area of rust previously noted has receded. This is due to the effect of Enviropeel's built-in inhibiting oil, which has stops existing corrosion and loosens surface rust allowing it to be wiped away.

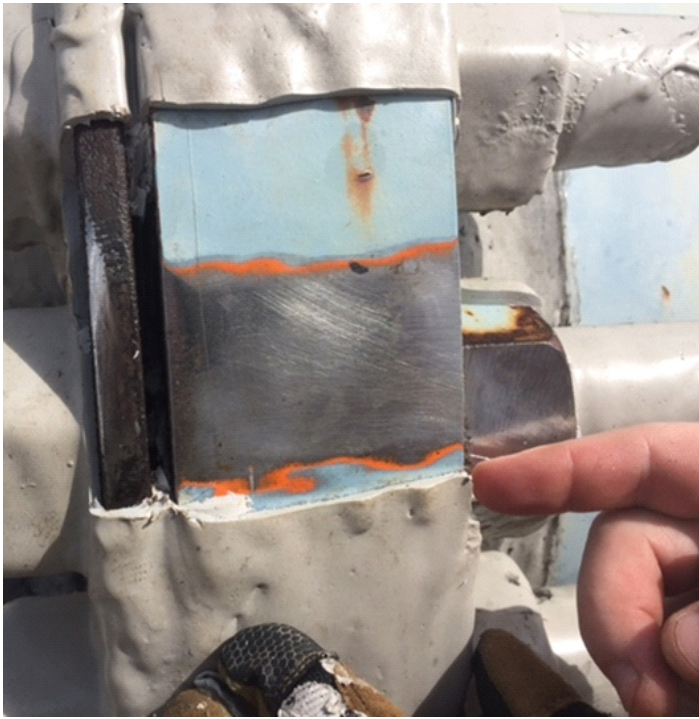
Second inspection on 6/13/17 after 8 months.

The Enviropeel is cut away from the same location as previously - as well as from the nut of the bolt which had not been uncovered since the original application. As can easily be seen there are no new signs of corrosion in either area. Also note that the external rust has receded even further.

Top: the substrate after removal for the second inspection. Note the total absence of rust from the bare steel.

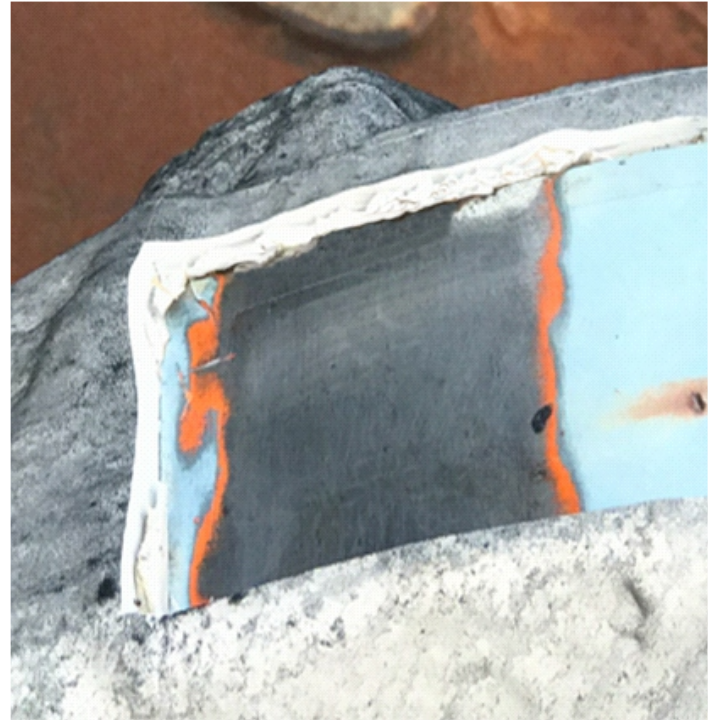
Final inspection on 7/18/18 after 21 months

The coating is removed from the same location as previously after nearly two years. There are no signs of new corrosion on the exposed steel and the rust staining has faded even further. Despite evident external contamination from flooding and the environment, inside the coating is unaffected.

Above: removal for the third inspection. Externally the coating shows dirt from the muddy environment but inside everything is in perfect condition.

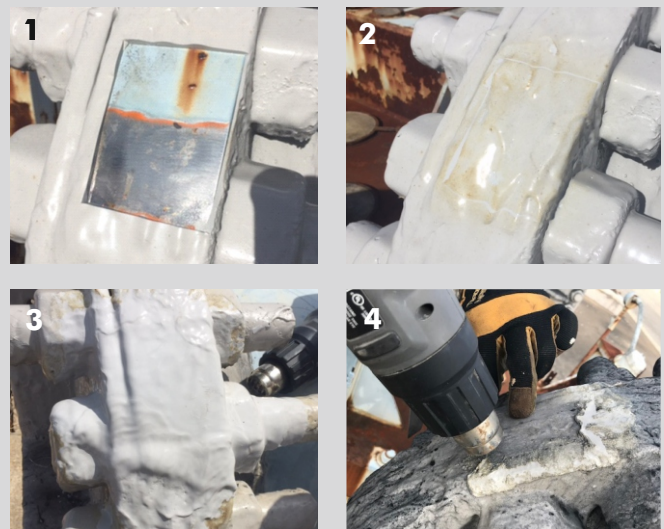
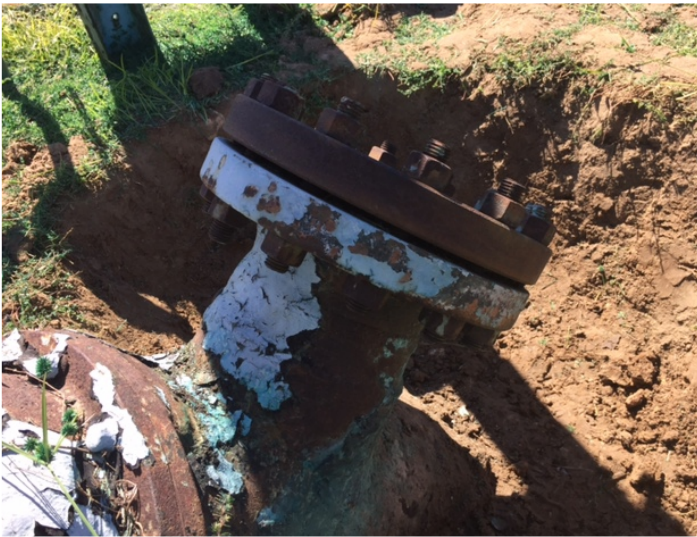
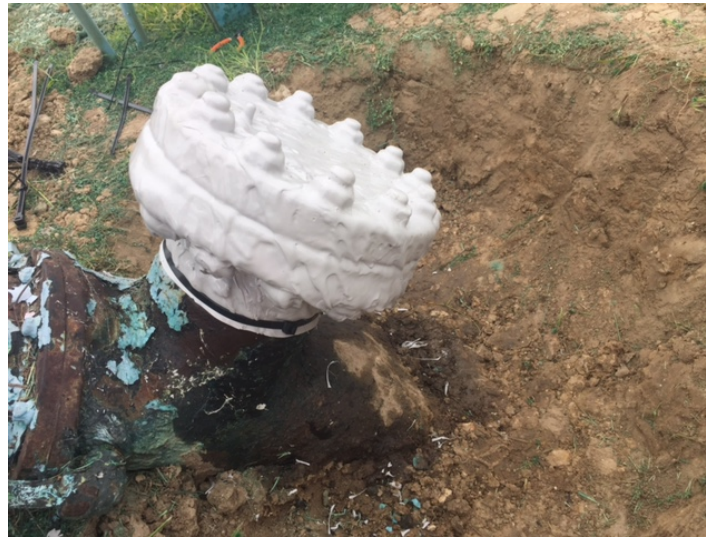
Repairing and resealing Enviropeel

Right: pic 1 shows patch removed, 2, 3 and 4 show heat gun repair after each inspection

Following each inspection the removed material was resealed using a standard electric heat gun to melt the removed patch back into the coating - even when heavily soiled. This is standard practice for inspection and maintenance on Enviropeel installations where the ability to easily test targeted locations without needing to redo the application saves time and money.

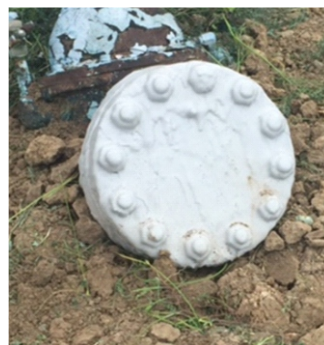
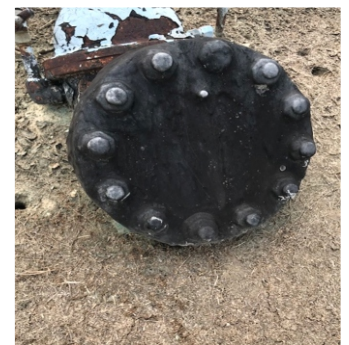
Test 2: encapsulating a 12" blind flange
Application date: 10/12/16

Top left: the original flange prior to application and, top right, after Enviropeel has been applied.

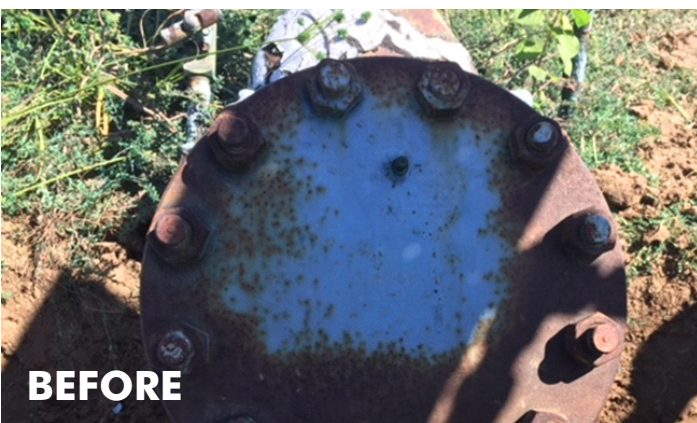
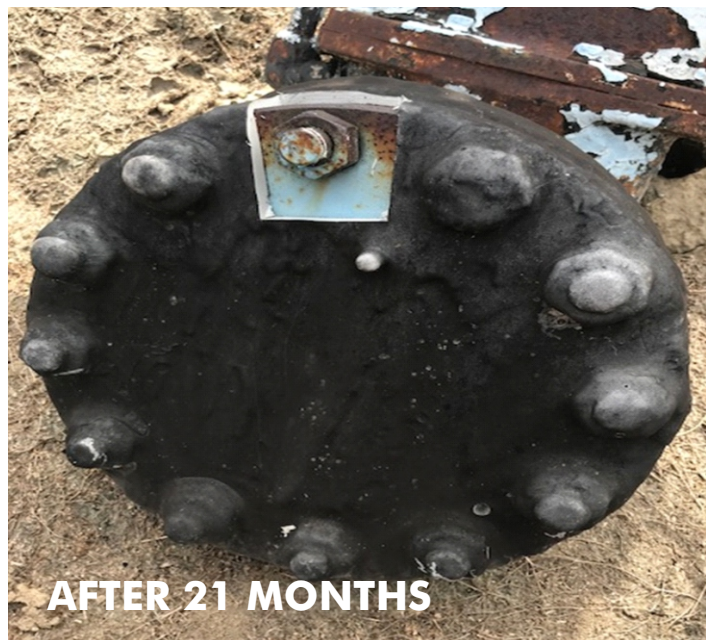
Not only was this blind flange in a soil-to-air interface, but it was submerged under water during Hurricane Harvey for over a week. For the test, soil was cleared away from the flange to allow access, as shown above. Enviropeel was then applied to encapsulate the entire flange and the pipework covered over. After 21 months of rain and flooding the encapsulation was almost completely black but, when the inspection area was cut away, showed the inside of the Enviropeel to be in its original condition and that no further corrosion had occurred on the blind flange, as you can see in the before and after photos below left and right.

Below left: condition of substrate prior to application.

Below right: inspection reveals substrate to be in original condition without any further corrosion despite flooding.
