RAIL BRIDGE IN WINTER

Successful trial application

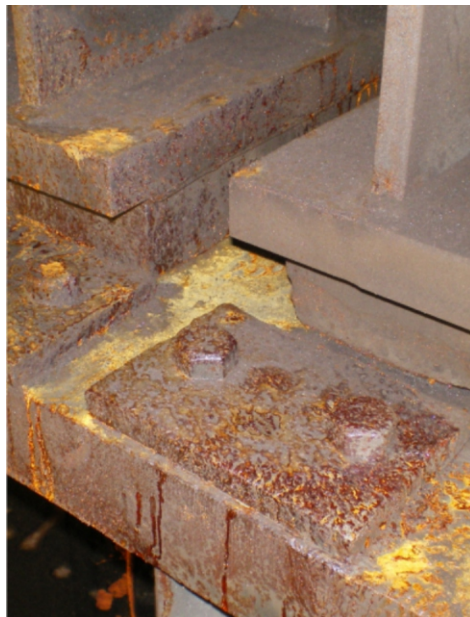
Top: the rail bridge was severely affected by the freezing conditions
Above left: the condition of the blasted substrate awaiting coating
Above right: manually applying the test coating to a freezing, wet substrate
Below: spray-applying the first coat of Alocit

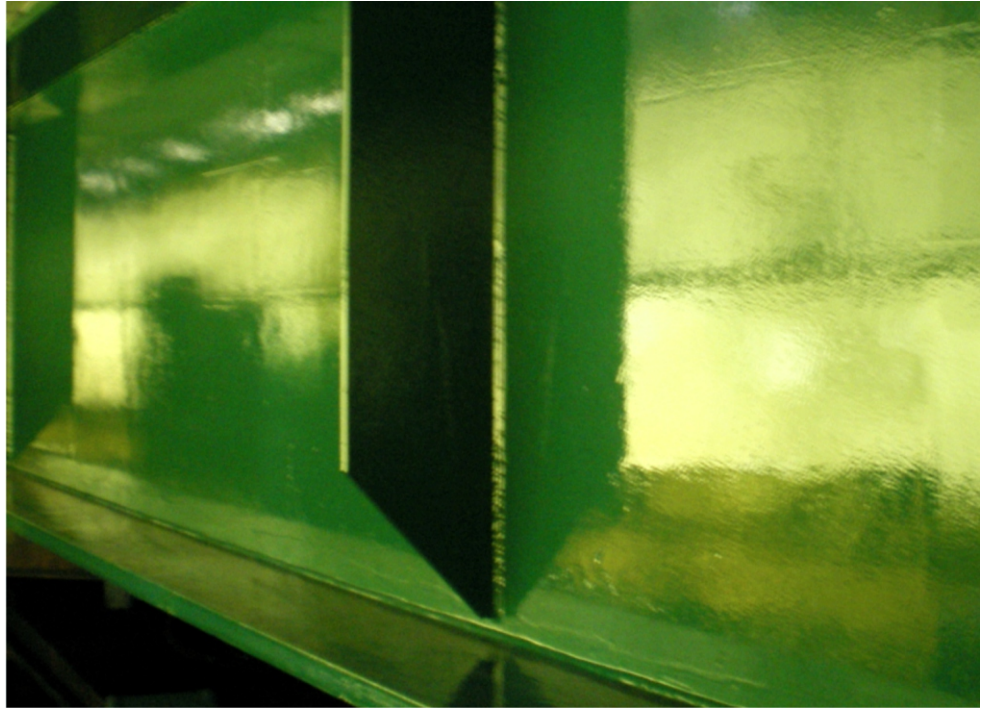
Above left: detail of first coat

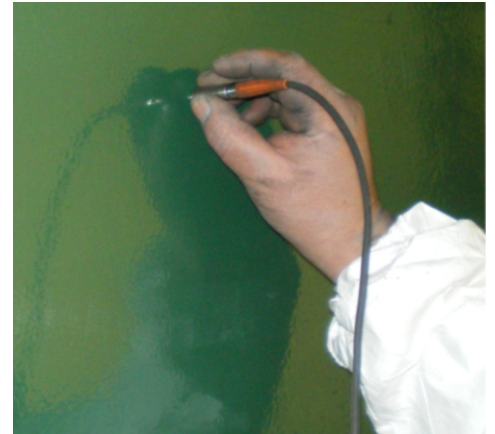
Above: finished coat in green

The green second coat was applied without any problems, producing a hard-wearing attractive finish for the bridge beams. Final testing showed optimum film thickness was achieved, with pull-off tests showing adhesion in excess of 2000 psi with all separations occurring through glue-line failure.

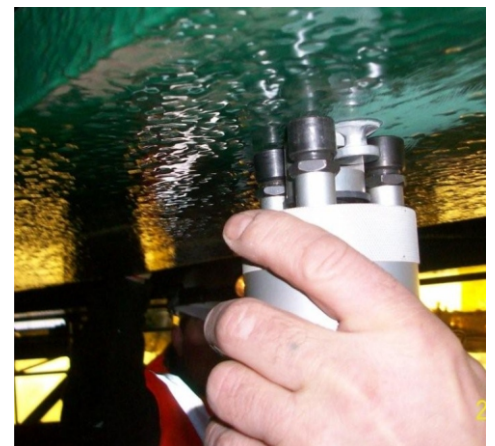
Below: testing the finished coating, results shown in panel below

Average DFT - 615 microns

Adhesion - range between 1600 psi and 2000 psi with all separations in the glue line.
