Bolt Corrosion Prevented by Corrosion-Inhibiting Spray-On Thermoplastic

ABSTRACT

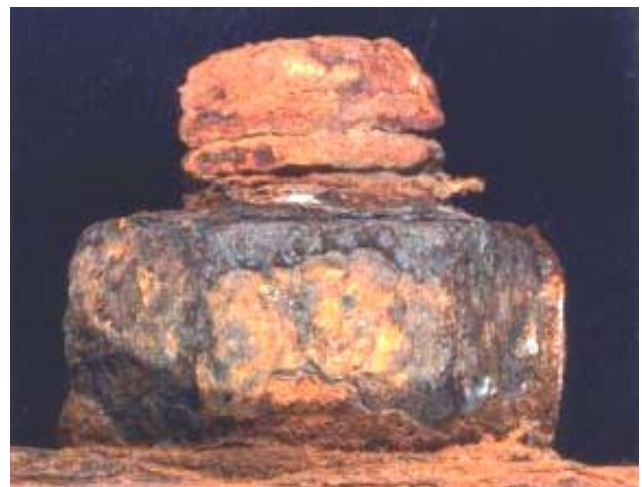
Figure 1: PTFE coated 8 μ m zinc electroplated low alloy fastener after only 18 months of testing in the splash zone

Similar results were obtained in the initial findings of the Fischer study, where all but one of a similar range of coatings exposed in the splash zone failed in 18 months, despite an exhaustive search for the most suitable candidates (Figure 1). Failures in washer coatings and materials were even more pronounced than those in the fasteners.

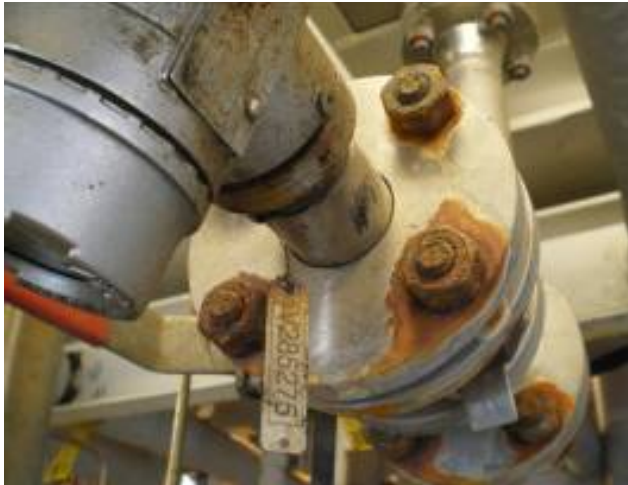
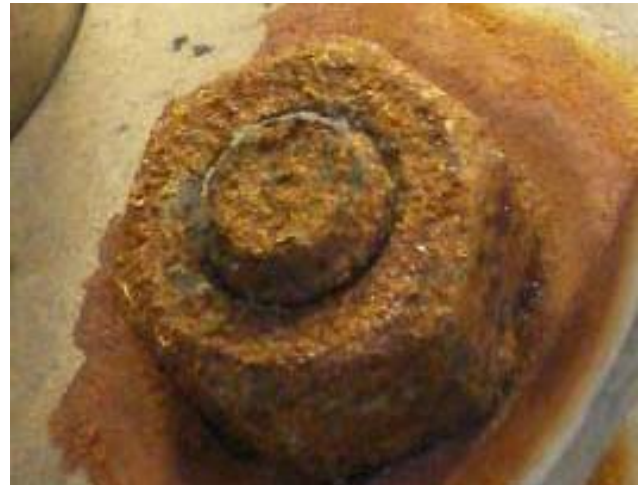
Figures 2 and 3: zinc-nickel plated L7 bolts on stainless steel flanges

The zinc/nickel plated L7 bolts shown in Figures 2 to 5 are from a newly constructed platform in the North Sea before it was commissioned. Typically, in a laboratory salt spray test, a zinc/nickel coating

Offshore however, conditions are far from normal; 1,000 hours is only 6 weeks. The bolts in these photographs have been exposed to constant salt-spray conditions for more than a year.

High levels of bolt corrosion on offshore structures are not uncommon and may be exacerbated by galvanic and crevice corrosion. In both the illustrated examples, the bolts are carbon steel; in one case the bolts are fastening stainless flanges, in the other, a combination of stainless and carbon steel. In such situations, low-alloy bolts are extremely vulnerable to galvanic effects.

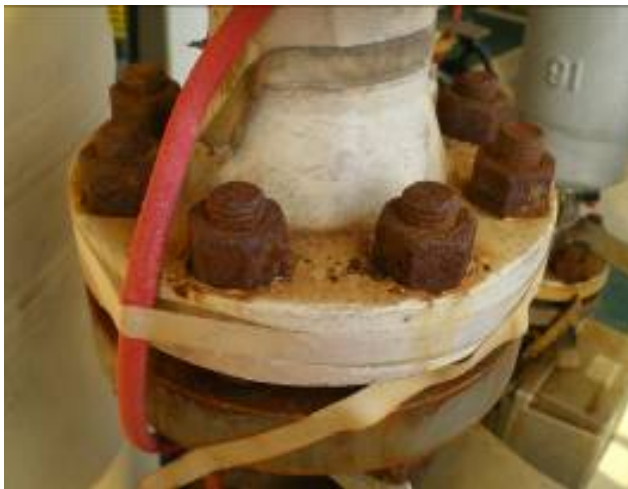
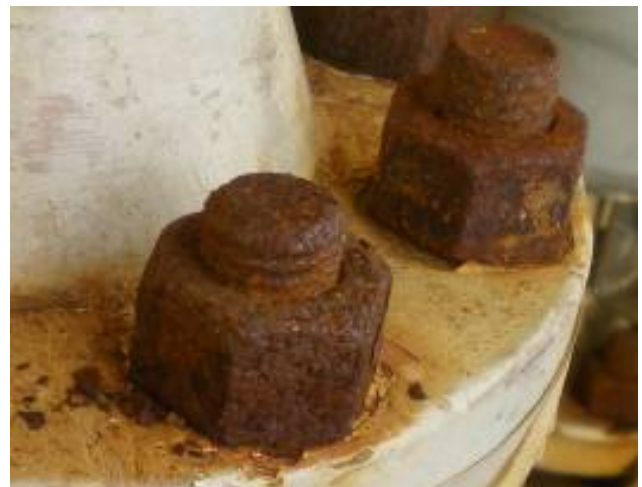
Figures 4 and 5: zinc-nickel plated L7 bolts on a mixed stainless/carbon steel substrate

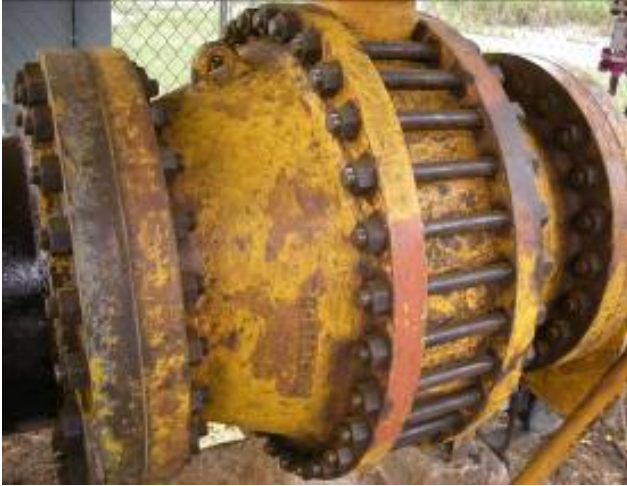
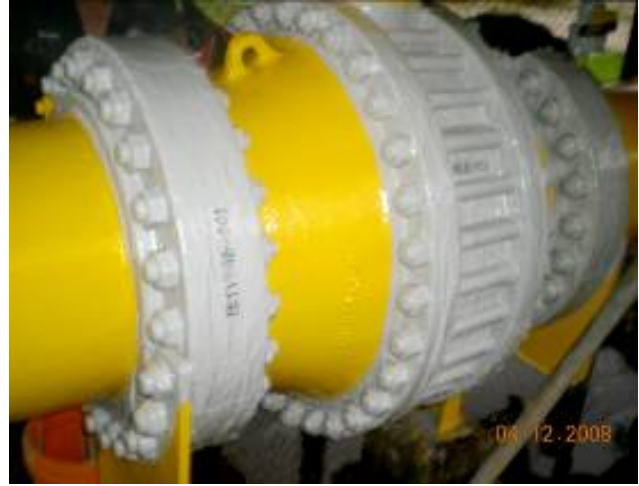
Figures 7 and 8: before and after application

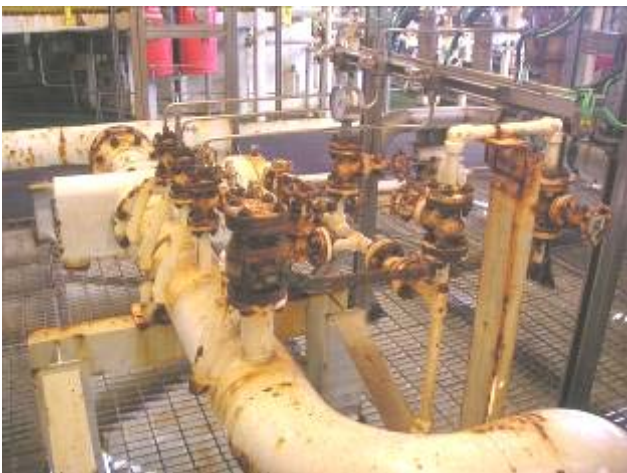
Figure 9: an area of corrosion affected valves

Since 2003, CIST has been in use on North Sea platforms for remedial protection of failing bolted systems. In the illustrated case the PTFE and electro-plating on low-alloy carbon steel bolts had not performed well (Figure 9) and a rolling program of CIST encapsulation using an Enviropeel system was implemented to prevent further deterioration.⁷

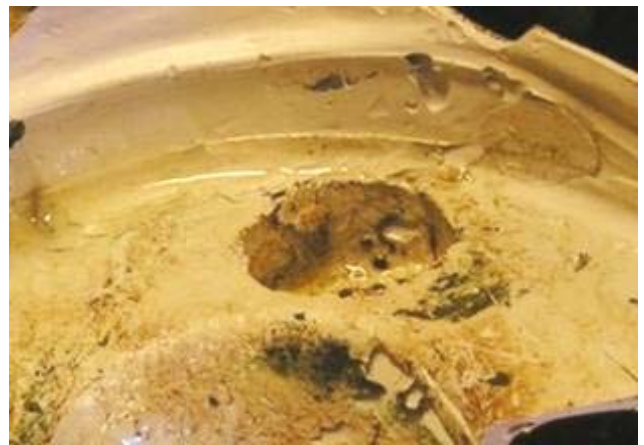
Figures 10 and 11: sample removal shows previously rusting substrate and inner surface of CIST encapsulation coated with oil

Over the years both the operator and application engineers have removed sample applications from flanges to assess their condition. Inspection has shown that further deterioration of the bolts has been arrested by the CIST application (Figures 10 and 11).

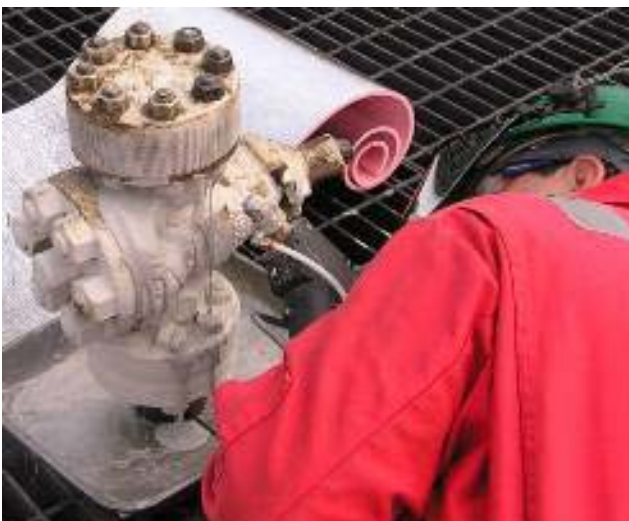
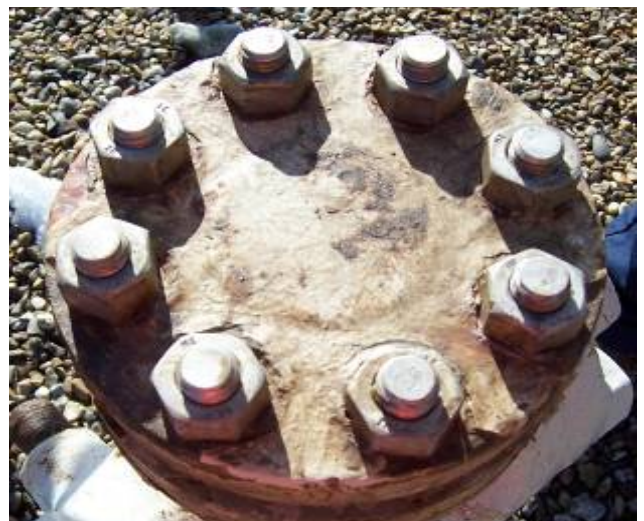
Figures 12 and 13: Application in 2005 and following removal in 2009

Bolt protection requirements are not just the province of the offshore oil and gas industry. Gas transport systems in Malaysia and Canada have used CIST systems to protect flanges and bolted systems for onshore installations and long-term testing in the UK at a major gas terminal was successfully concluded in 2009 after 4 years of testing. Examination of the substrate following removal of the coating showed that oil was present on all internal surfaces and no corrosion had occurred (Figures 12 and 13). The terminal is directly adjacent to the North Sea and, while annual precipitation is low, the installation is subject to high salt and moisture levels.

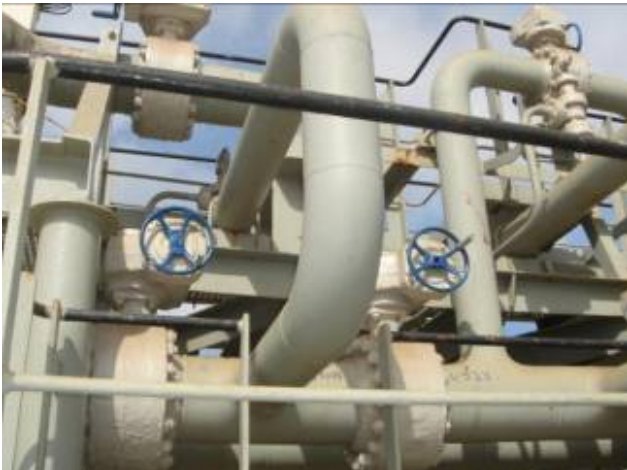
Figure 14: CIST protected deck pipework on LPG carrier

On LPG carriers, flange bolts required repainting several times a year prior to the use of CIST which is used to protect flanges and valves on all deck pipework (Figure 14). The use of CIST has eliminated the need for repainting on such areas for these vessels.

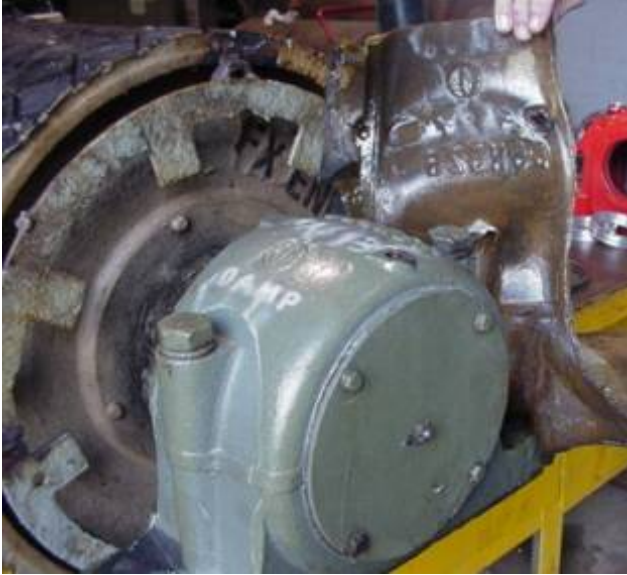
Figure 15: removing CIST material from trial bearing shows impeccable condition of protected substrate

In Figure 15, removal of CIST from trial bearings shows the bearing housing to be unaffected while the unprotected roller shows clear signs of deterioration.
